2006 L320 HSE Suspension Issues - Resolved. Valve Blocks, Compressor.

- ▶ Information for Others to leverage from
- ▶ Car is in Ireland, it is a passenger unit (not 2-seater commercial).
- ▶ Originally Irish car, not imported as used.
- ▶ I purchased in June 2020 with 136,000kms as a 2 owner car
- ▶ (2nd owner had it for a couple of months and must have had 2nd thoughts)

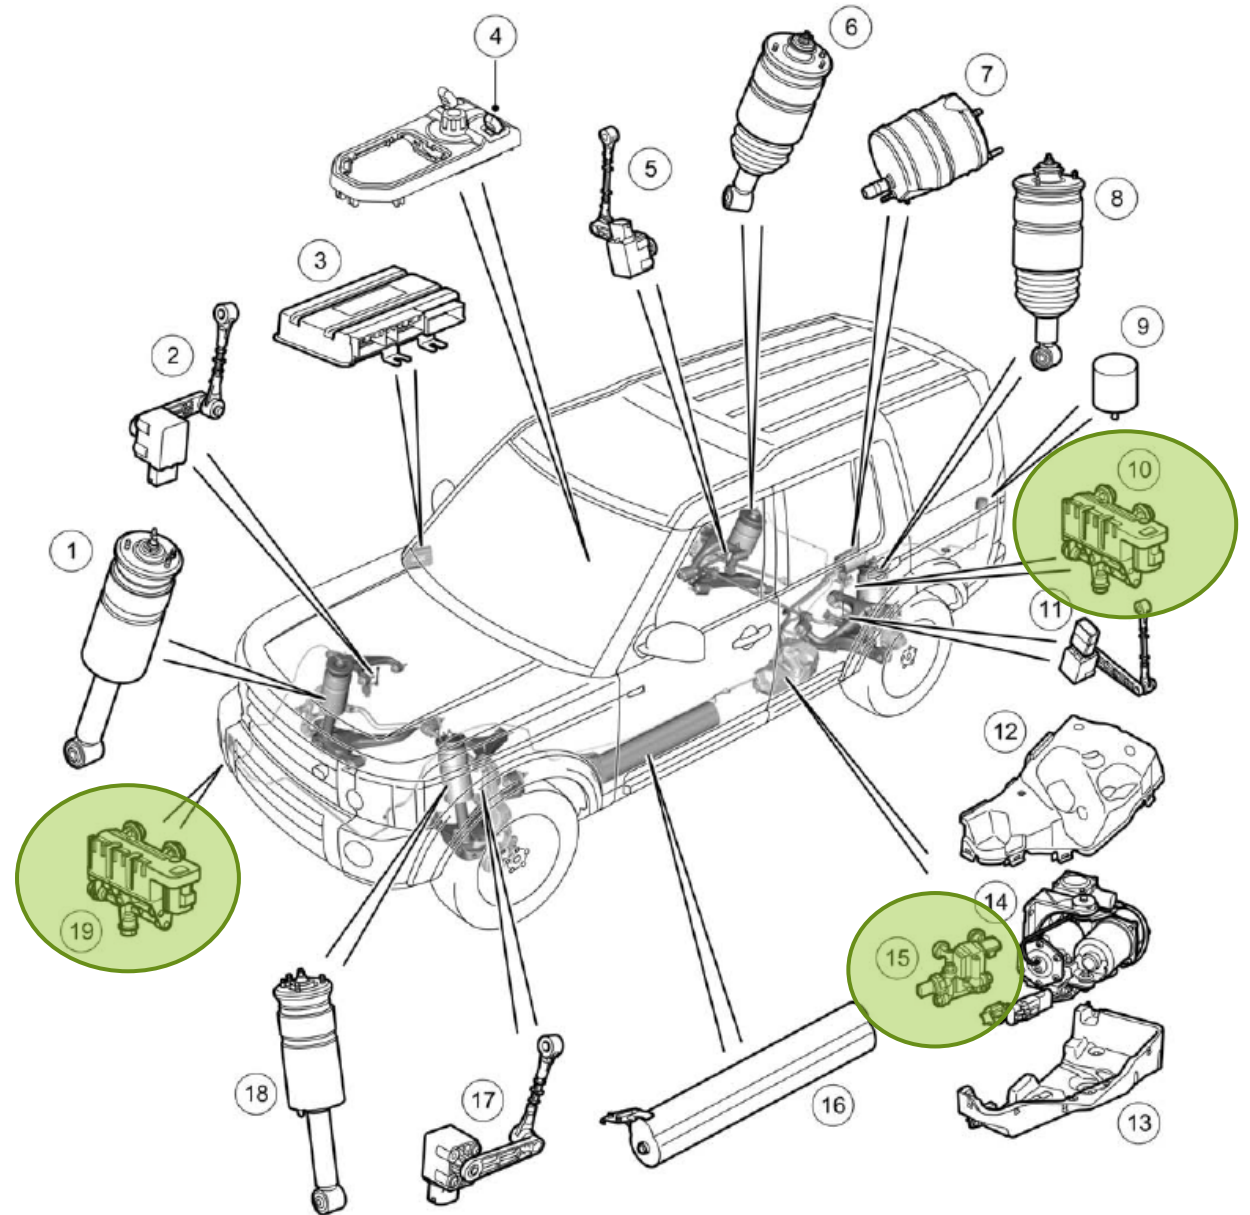
Valve Blocks, how they work in principal.

- ▶ Rear and Front Valve Blocks look the same are different part numbers RVH000055 and RVH000095 because of orientation of connections, and maybe some other reasons that are not apparent to me.

- ▶ Reservoir and Compressor Feed the Middle valve block on separate connections, the Pressure sensor is on the Reservoir side, so then the valve is close you are reading reservoir pressure only. 2 other connections feed the front and rear valve blocks.

- ▶ The middle valve block has one valve, so when it opens it effectively opens the lines between front and rear valve blocks and the compressor and reservoir. A crude view is, that reservoir will overcome pressure requirements in the system until it can't, then the compressor kicks in.

- ▶ Front and Rear valve blocks operate on same principal. There are 3 valves in each of these blocks, 2 corner valves and 1 crosslink valve (middle). Corner valves control the flow of air in/out of individual air springs and the cross link provides the connection between the 2 springs on each axle. When de-energized all 3 valves close in the block, meaning when you whip out the system fuse you should be able to zone in on a leak pretty quickly as the self levelling is disabled.

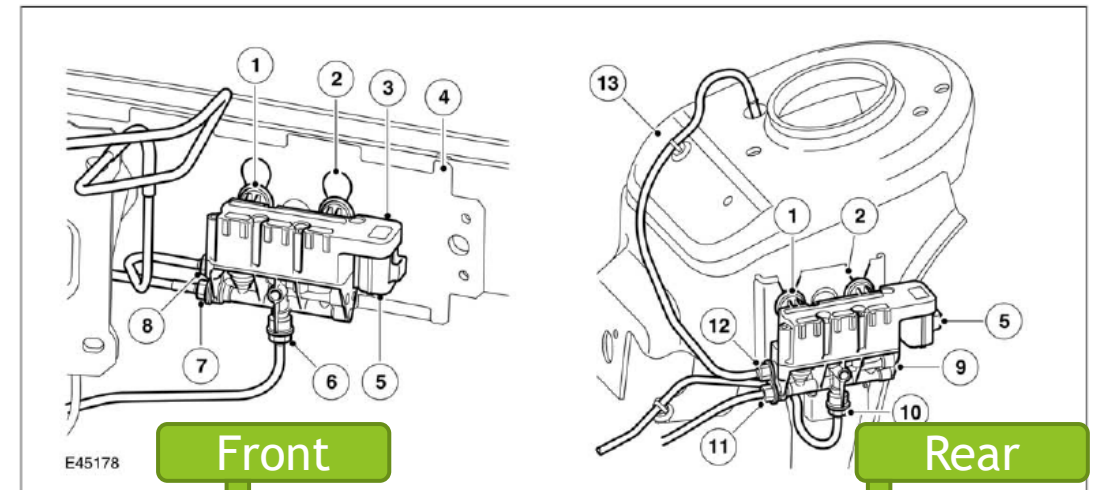
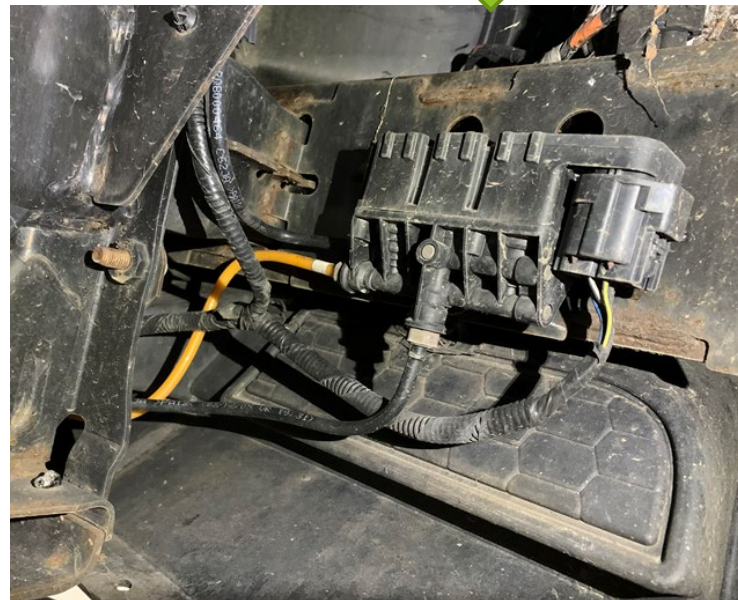
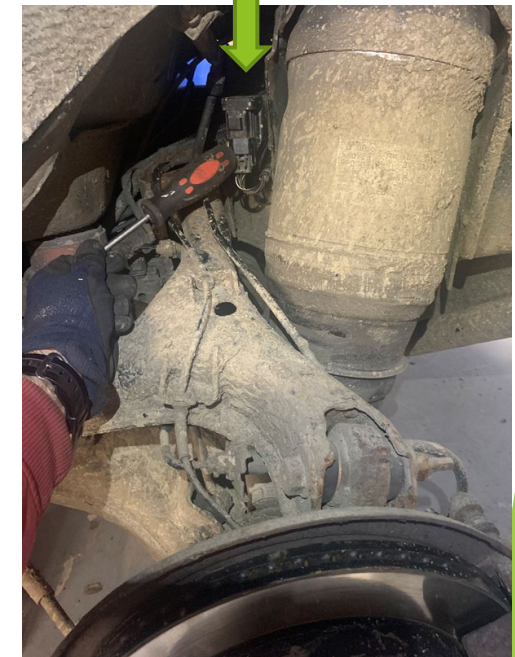
Valve Block

Front Valve Block is easy to work on, accessed by peeling back wheel arch liner and removing front RHS wheel for more access.

Middle one valve is also easy to access, drop the compressor cover and work away!

Rear Valve block is also easy with appropriate method. I will give you some photos of how I did it. On next page.

Crack open the connections, and once air is heard venting, let the pressure dissipate before removing the Voss completely - 16Bar!

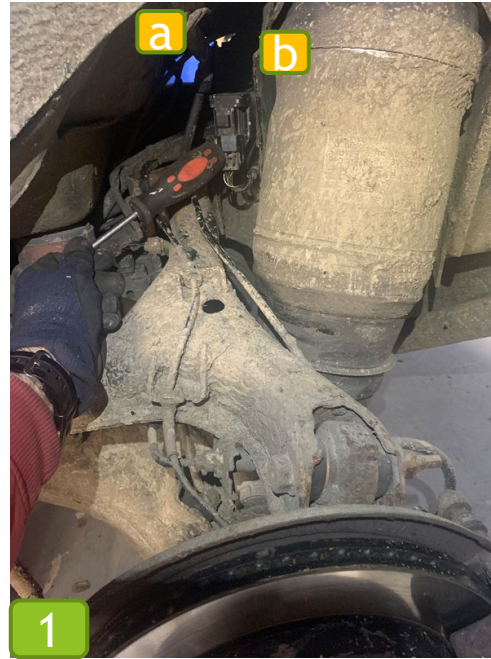
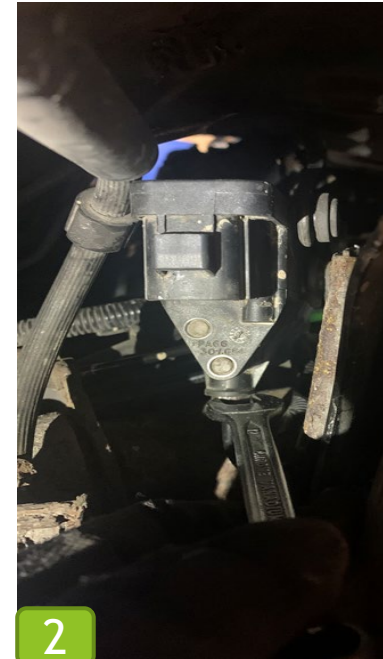
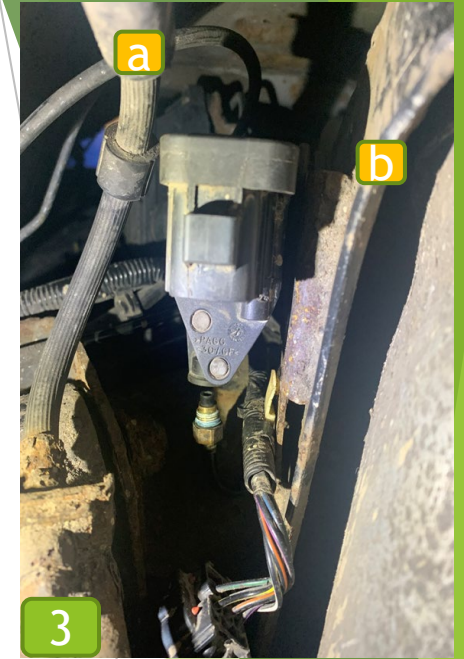
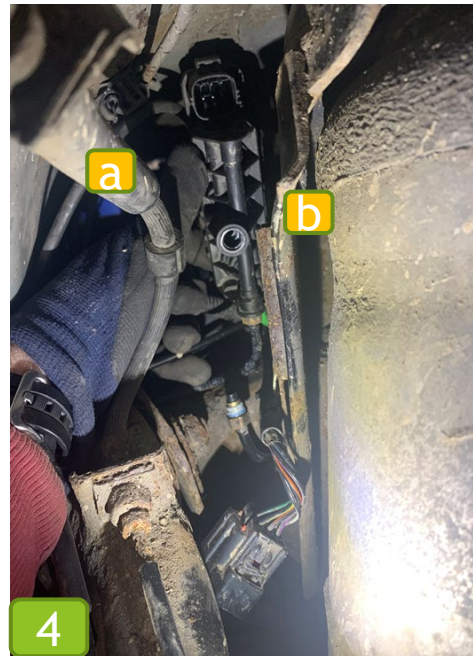
Rear Valve Block

Put car in access mode, then lock suspension by holding the button down until lock symbol appears and you get the friendly message confirming status.

Jack car up and support on axle stand. Take off rear left wheel, and you will see the valve block where my black/red screwdriver is in the photo 1.

Remove electrical connector and pop the valve block upwards out of the mounting position so it is free from mount. This will give you room to get your 12mm spanner onto the bottom Voss connector per photo 2. Photo 3 shows the connector removed.

Rotate the valve block backwards by 90degrees. This will give you access to the remaining 2 voss connectors per photo 4. Follow the anchor points a and b through the photos, this should help you figure out what way the camera is pointing as it may not be clear when looking at photo 4 in isolation.

That's it - you're done. Install is reverse sequence of above steps. If you have new voss connectors, then see details further on in this document.

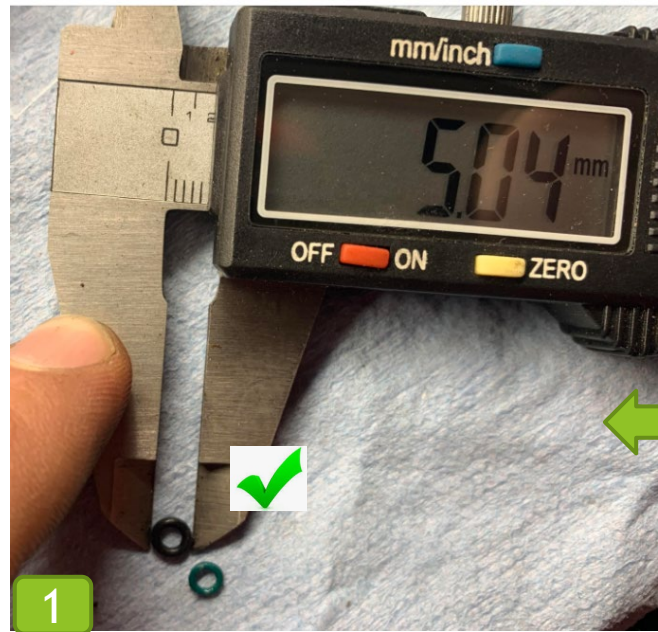
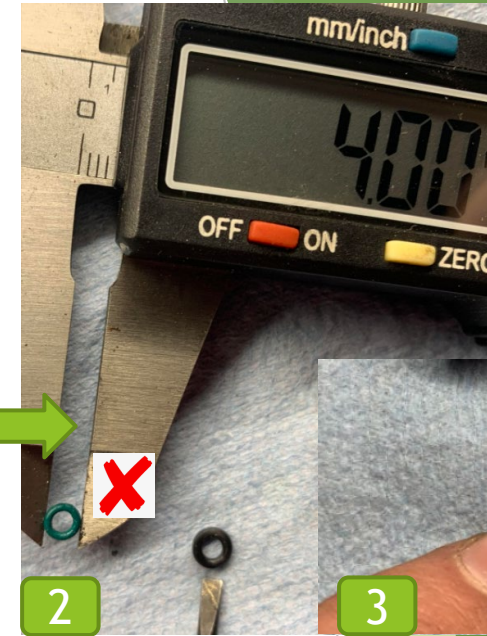
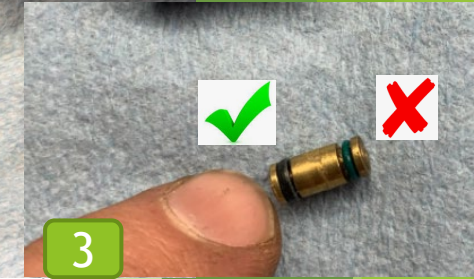
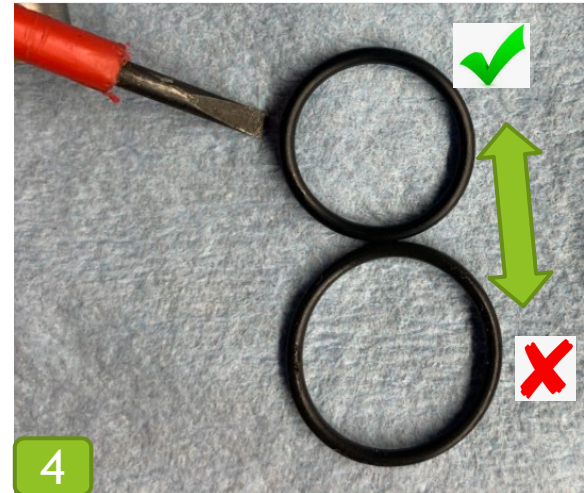
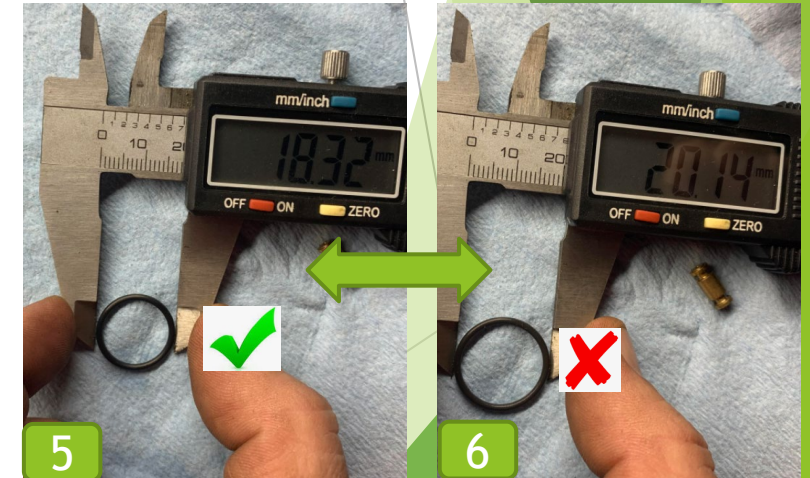
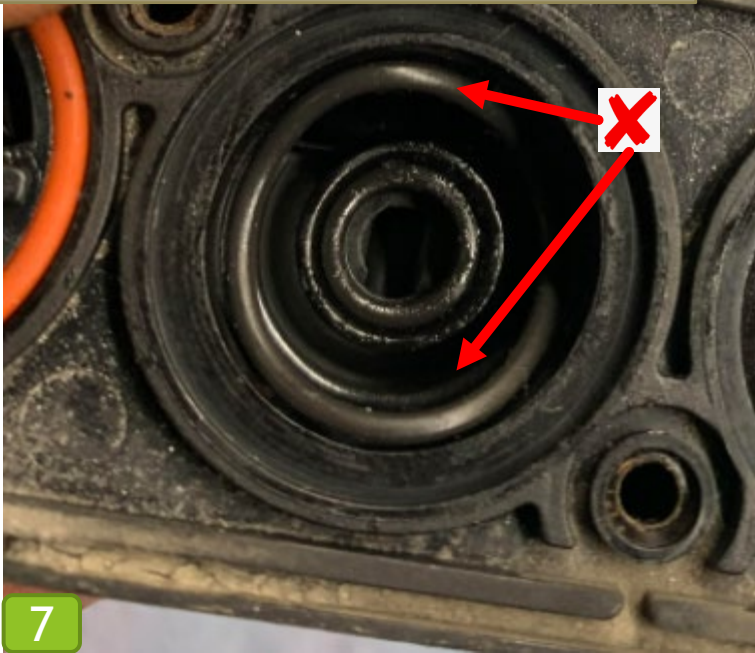
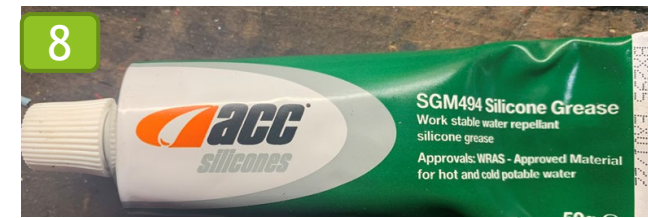
The Orings

Screwdriver always points to the correct Oring.

Photo1, 2 & 3 - Correct seal is the bigger one, the green one was supplied blue company in US

Photos 4, 5, 6, 7 show comparison of other Oring, and how it wouldn't seat correctly. Photos are self explanatory. There were issues with all Orings, but I chose these 2 to compare here.

As I mentioned earlier, the supplier I would recommend is 4X4Airseals.com (UK supplier). I will compare the correct seal with those supplied from company in US to give you an idea of how much of a problem it was.

Photo 8 - Use Silicone Grease on the Orings - sparingly!

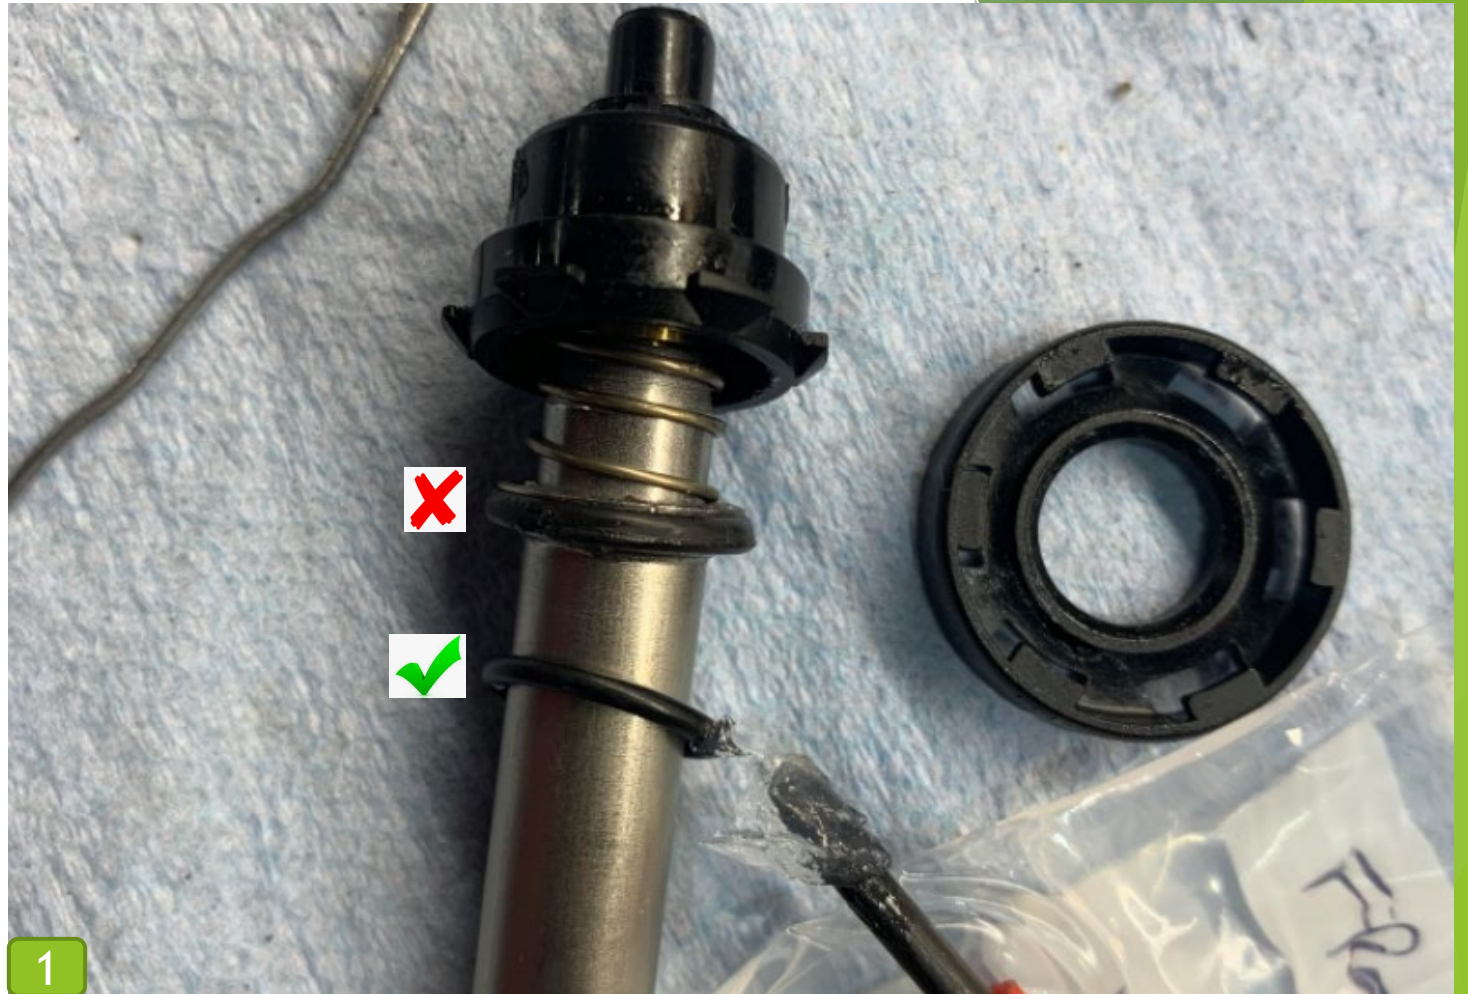
This is the one I mentioned earlier. It was a pig.

There is just one O-ring for this position, but I put both on for comparison photo. As you can see the crap one is massive in comparison (too thick). You can see it has even deformed from 48 hours under severe compression.

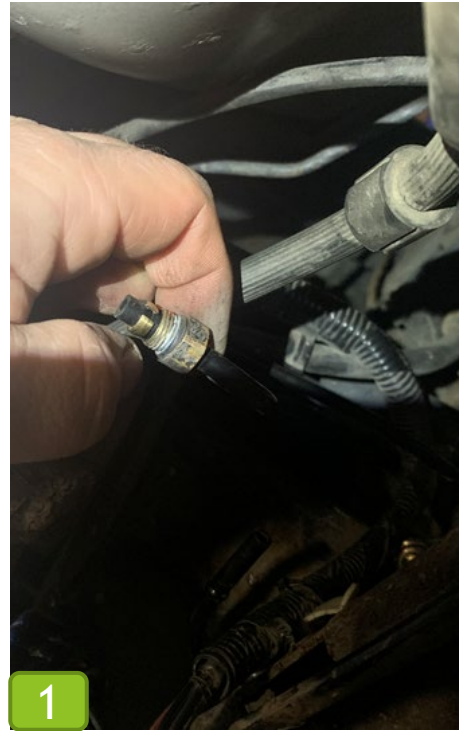
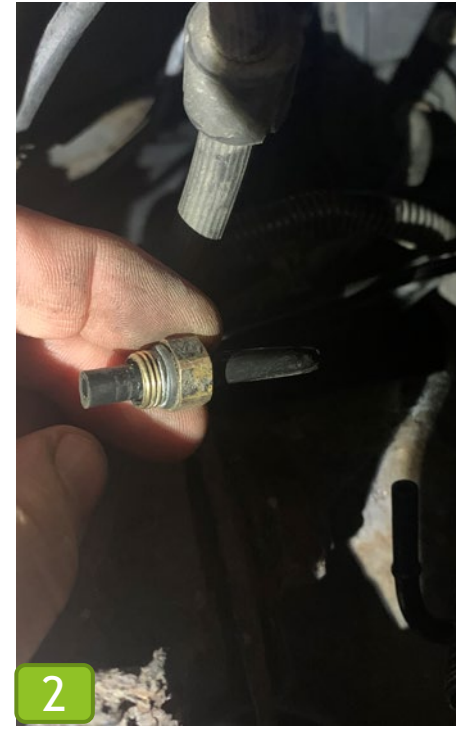
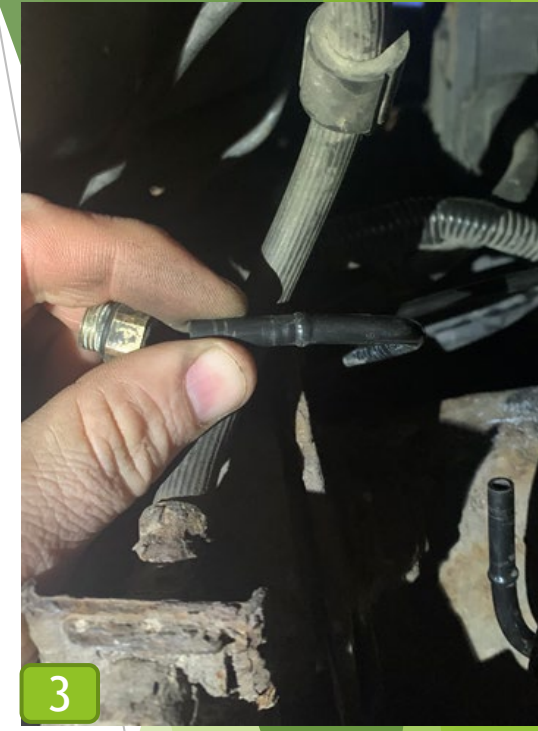
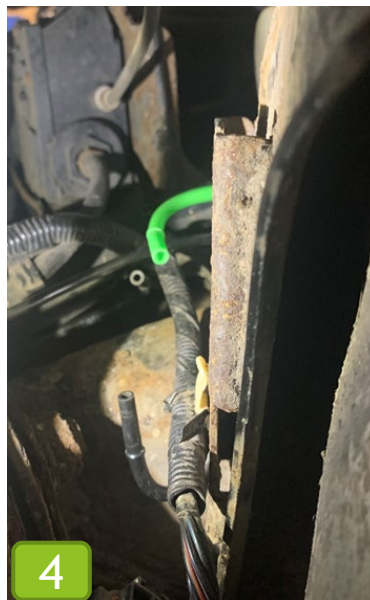
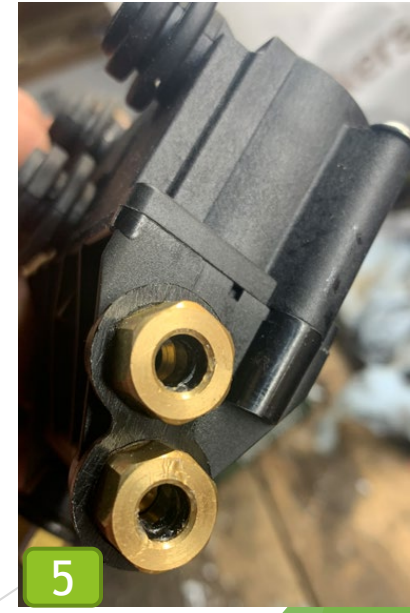
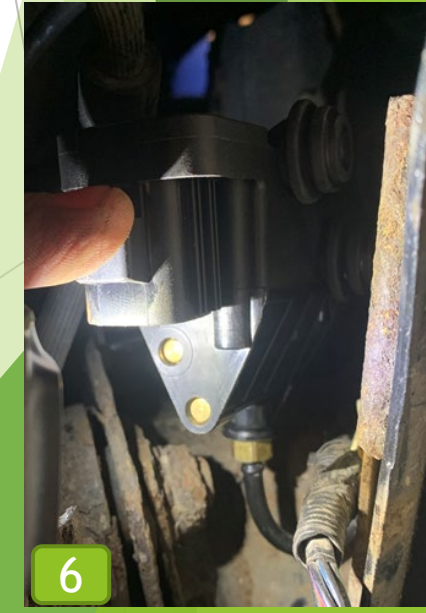
Using the new Voss connectors supplied on New Valve block

Photo 1 - Push the Threaded connection back to reveal the inner split ring and rotate the ring so you can see it. Gently widen the split with a flat faced screwdriver and remove the split ring.

Photo 2 & 3 - remove the threaded voss connector and inspect and clean up the tube.

Photo 4 - 3 airline voss connectors removed at rear valve block location.

Photo 5 - add a little silicone grease to the Orings inside the new Voss connectors.

Photo 6 - push the tube home into the Voss connector, you will feel a click, and then pull the tube back out to make it grip into the split ring. My advice for the Rear valve block, is use the reverse install sequence mentioned earlier and valve block rotated up 90 degrees from the home position. i.e. start with the green tube, LH rear spring connection, then the main supply air and finish with the RH rear spring connection.

Ensure you have a good grip of the valve block and tube BEFORE you start pushing it in, you don't want to find it grips on the split ring before the tube is pushed fully home.

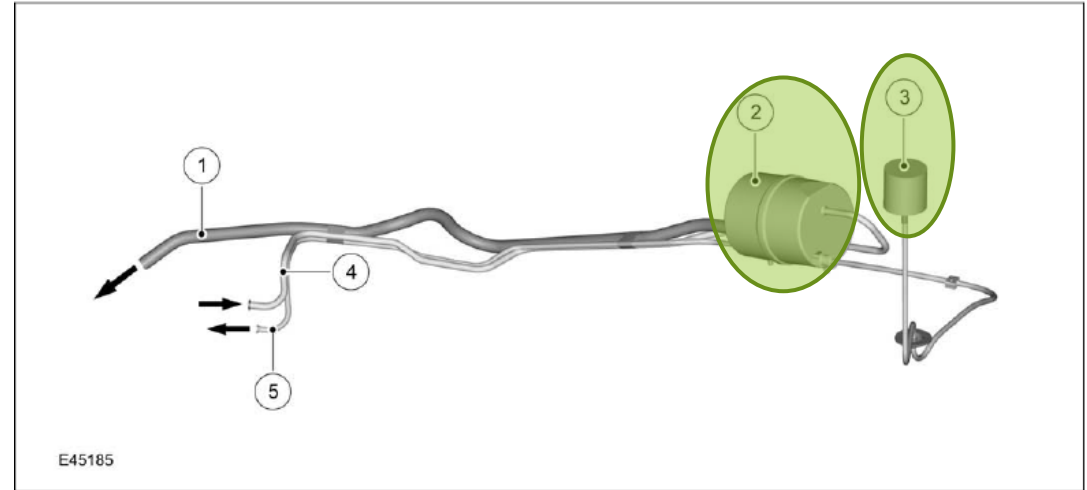
Air Intake Assembly

It is doubtful these will ever be your problem. The intake filter, item 3, is inside the car so unless you live in a dusty desert and the inside of your car requires a shovel to clean it out rather than a vacuum cleaner I think you will be ok.

The silencer - well....I think this will generally be ok too. It provides attenuation duties for both supply and exhaust air.

Interestingly, the exhaust air line (larger diameter pipe), item 1, runs from the silencer back to discharge right beside the compressor.

Item	Description	Item	Description
1.	Exhaust to atmosphere	4.	Exhaust air from air supply unit
2.	Inlet and exhaust silencer	5.	Air inlet supply to air supply unit
3.	Air inlet filter
